Annual Inspection

Peasemore Parish Council

Peasemore Parish Council - Play Area

Hill Green Lane, Peasmore

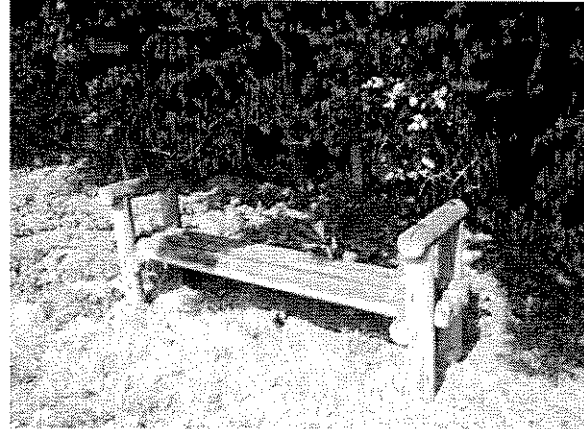
There are stinging nettles/tree branches protruding into the surrounding area - Cut back and maintain area

There is some evidence of rot in the timber - Monitor for any further deterioration and replace as required

The timber has a number of splits (shakes) although these are not considered to be a problem at present - Monitor to ensure the splits do not cause any instability and remove any rough or sharp edges

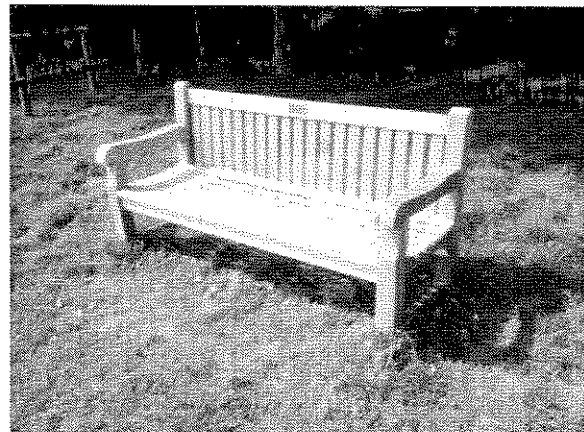
This item is satisfactory - no work required

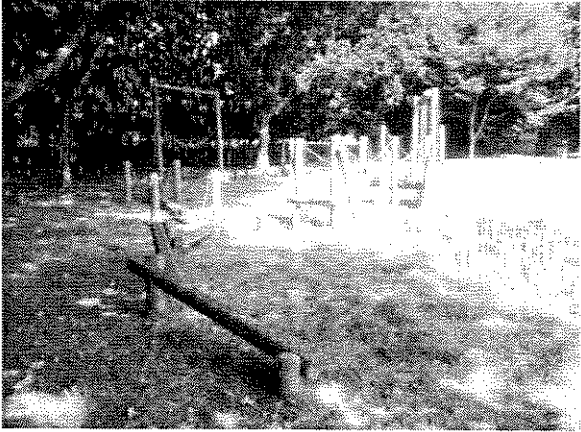
<p>Finding 1 There are stinging nettles/weeds beneath the item - Remove nettles / weeds and maintain area</p>	<p>Finding 2 The chain openings are in excess of the 8.6mm as recommended by BS EN 1176 - Monitor use and replace with compliant chains during next maintenance cycle.</p>
<p>Finding 3 There is some chain wear - Monitor for any further deterioration and replace when 40% worn</p>	<p>Finding 4 The timber has a number of splits (shakes) although these are not considered to be a problem at present - Monitor to ensure the splits do not cause any instability and remove any rough or sharp edges</p>
<p>Finding 5 A number of eyebolt fixing(s) have worked loose - Secure all loose fixings</p>	<p>Finding 6 There is/are bolt cap covers missing or damaged on the item - Replace missing or damaged bolt cap covers</p>

<p>Finding 7 There is some evidence of rot in the timber - Monitor for any further deterioration and replace as required</p>	<p>Finding 8 There is some strimmer damage apparent on the posts, this can penetrate the preservative applied to the timber and accelerate the rotting process - Monitor for any deterioration (rot) and replace as required</p>
<p>Finding 9 The timber has a number of air cracks apparent, the splits will have penetrated the preservative applied to the timber and allow water ingress to the unprotected areas - Monitor for any deterioration (rot) and replace as required</p>	<p>Finding 10 The surface has eroded in some areas creating potential trip hazards - Reinststate the surface to remove trip points</p>

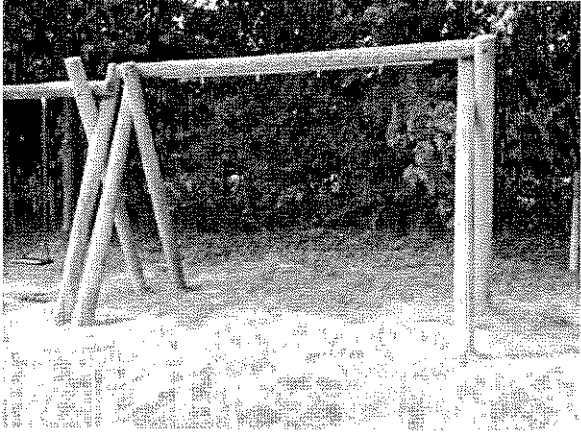
<p>Finding 1</p> <p>There are weeds/vegetation growth between or around the edges of the surfacing - Remove weeds/vegetation growth</p>	<p>Finding 2</p> <p>A number of fixing(s) have worked loose - Secure all loose fixings</p>
<p>Finding 3</p> <p>The seat(s) and suspension were missing at the time of inspection and the inspector was unable to make a full compliance assessment - Replace missing seat(s) and suspension</p>	<p>Finding 4</p> <p>The timber has a number of splits (shakes) although these are not considered to be a problem at present - Monitor to ensure the splits do not cause any instability and remove any rough or sharp edges</p>
<p>Finding 5</p> <p>The timber crossbeam on this item has severe rot - Remove and replace all affected timber sections</p>	<p>Finding 6</p> <p>There is some evidence of rot in the posts - Monitor for any further deterioration and replace as required</p>

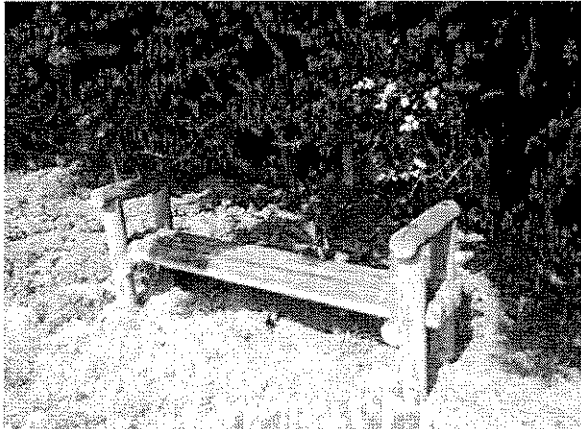
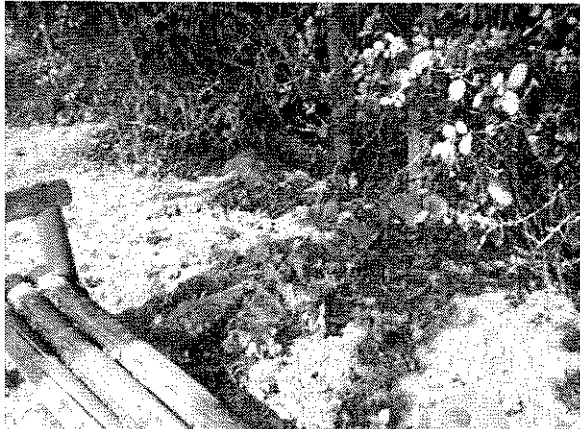
5 - Low Risk (Finding 1)			
Item:	Ancillary Items - Bench	Risk Level:	L - Low Risk
Manufacturer:	Owner/Operator	Surface:	N/A

Finding:	There are stinging nettles/tree branches protruding into the surrounding area		Action: Cut back and maintain area

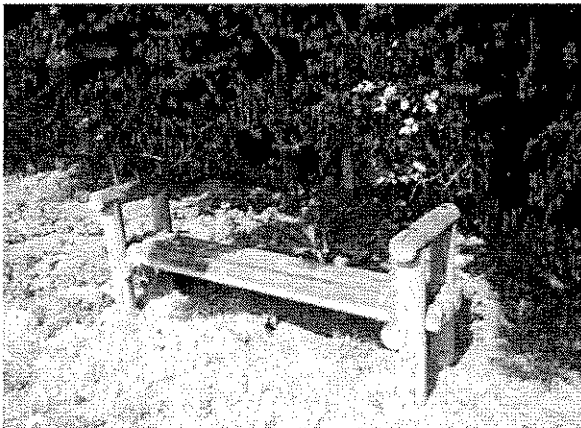
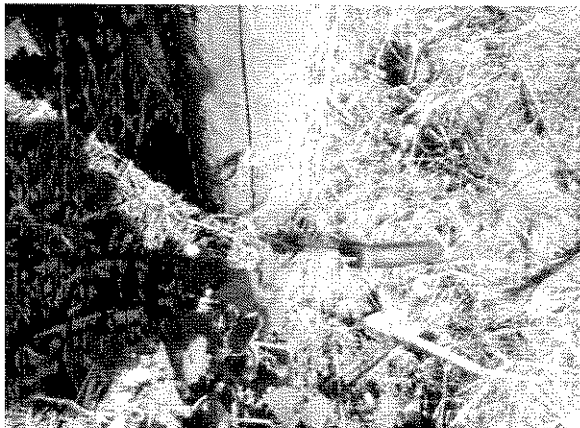
6 - Low Risk (Finding 2)			
Item:	Ancillary Items - Bench	Risk Level:	L - Low Risk
Manufacturer:	Owner/Operator	Surface:	N/A

Finding:	There is some evidence of rot in the timber		Action: Monitor for any further deterioration and replace as required

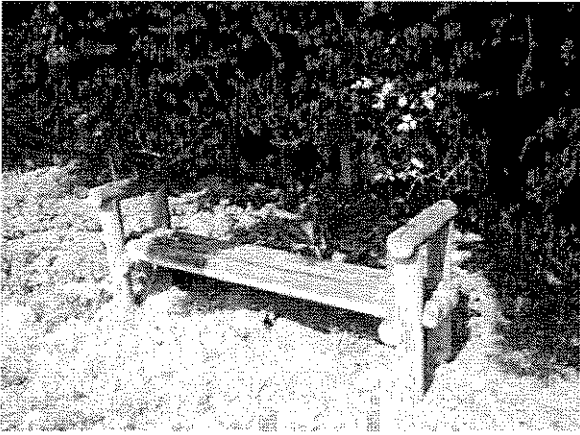
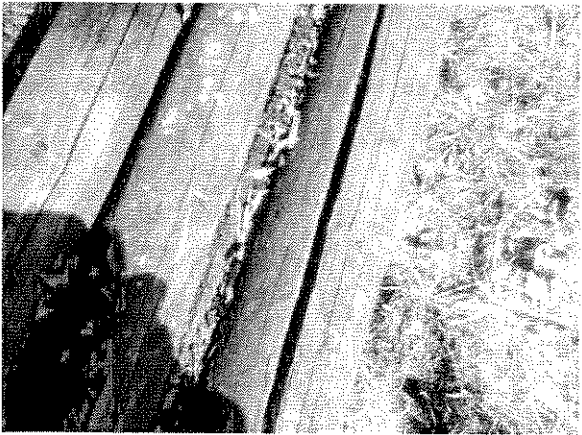
6 - Low Risk (Finding 3)			
Item:	Ancillary Items - Bench	Risk Level:	L - Low Risk
Manufacturer:	Owner/Operator	Surface:	N/A

Finding:	The timber has a number of splits (shakes) although these are not considered to be a problem at present		Action: Monitor to ensure the splits do not cause any instability and remove any rough or sharp edges

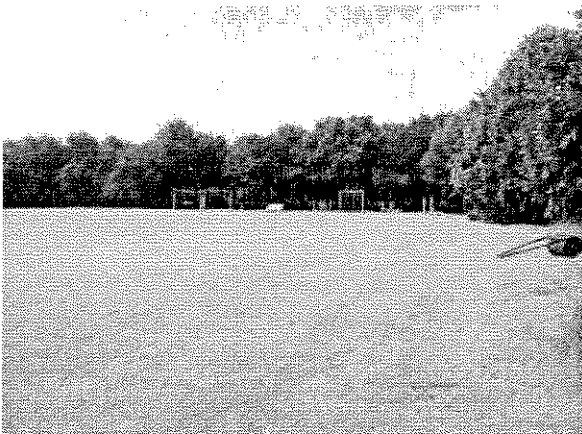
7 - Very Low Risk (Finding 4)			
Item:	Ancillary Items - Site General	Risk Level:	V - Very Low Risk
Manufacturer:	Owner/Operator	Surface:	N/A

Finding:	It is recommended that information signs with emergency contact details are installed at each entrance/exit point to the playground		Action: Provide in accordance with the recommendations set out in BS EN 1176

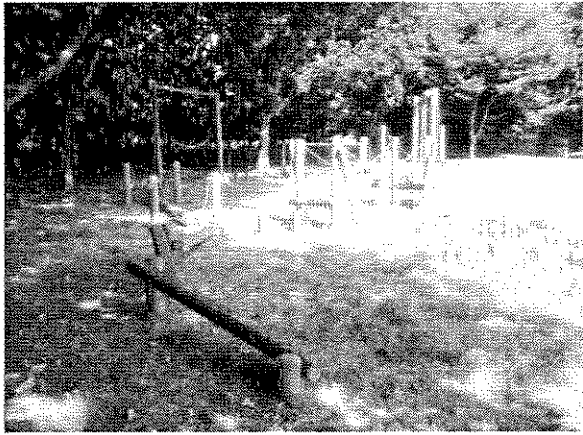
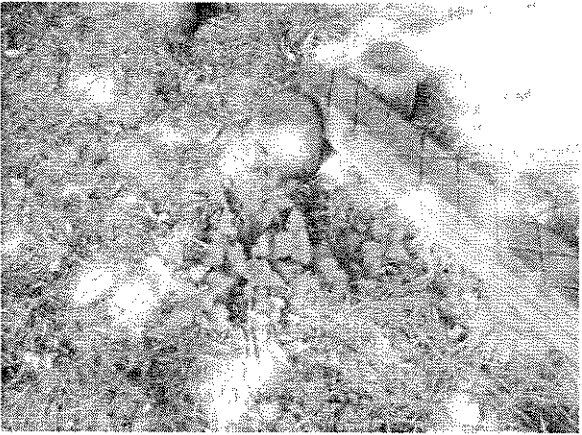
Finding:	There are stinging nettles/weeds beneath the item		Action: Remove nettles / weeds and maintain area

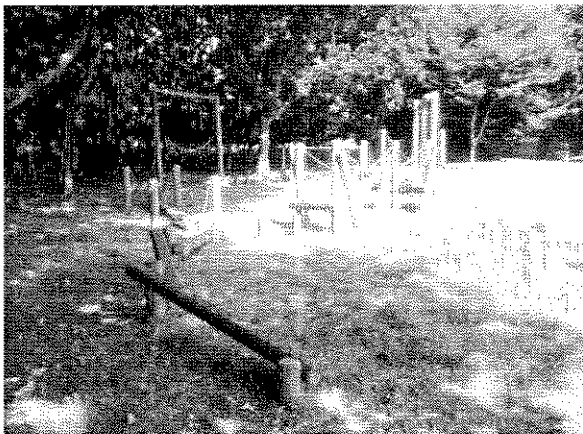
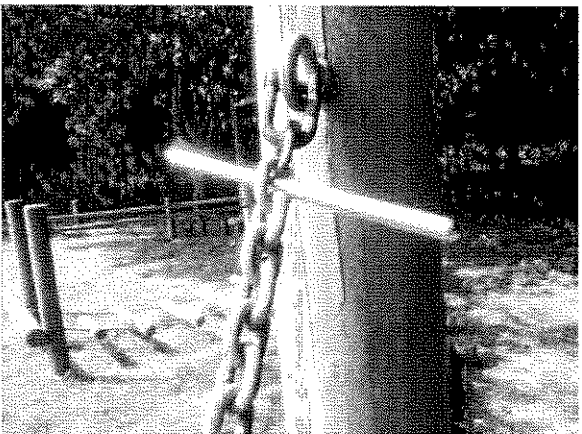
Finding:	The chain openings are in excess of the 8.6mm as recommended by BS EN 1176		Action: Monitor use and replace with compliant chains during next maintenance cycle.

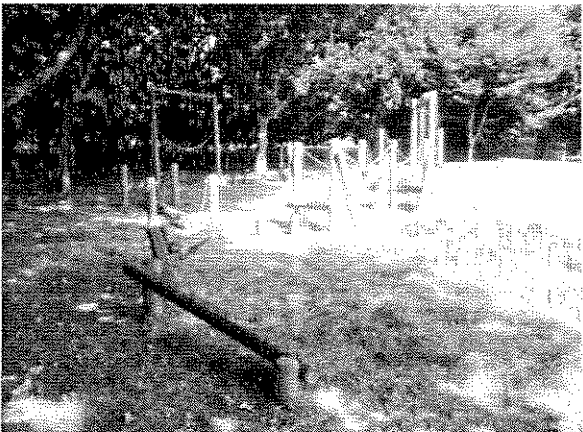
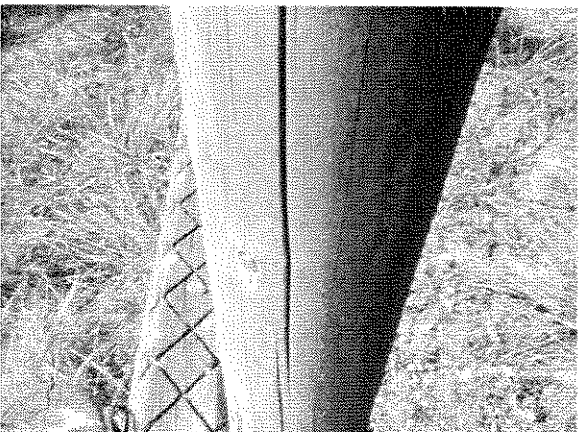
6 - Low Risk (Finding 4)

Finding:	The timber has a number of splits (shakes) although these are not considered to be a problem at present	Action:	Monitor to ensure the splits do not cause any instability and remove any rough or sharp edges
-----------------	---	----------------	---

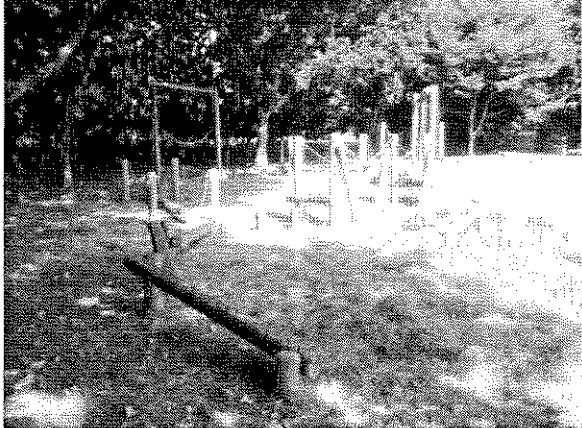
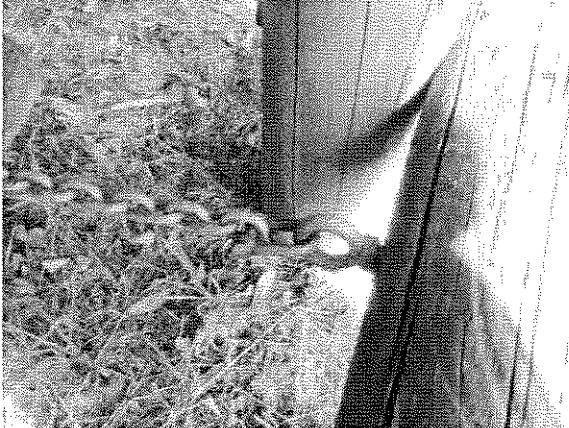
4 - Low Risk (Finding 4)

Finding:	A number of eyebolt fixing(s) have worked loose	Action:	Secure all loose fixings
-----------------	---	----------------	--------------------------

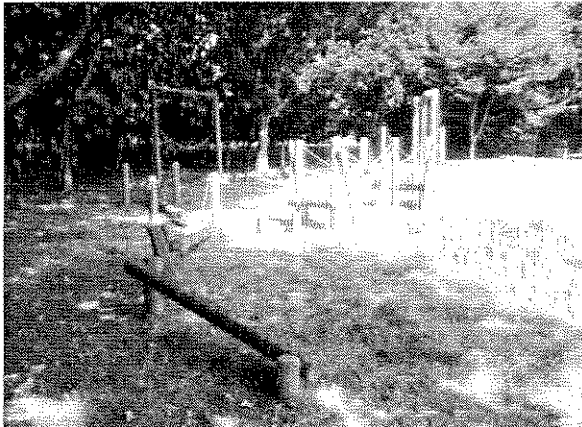
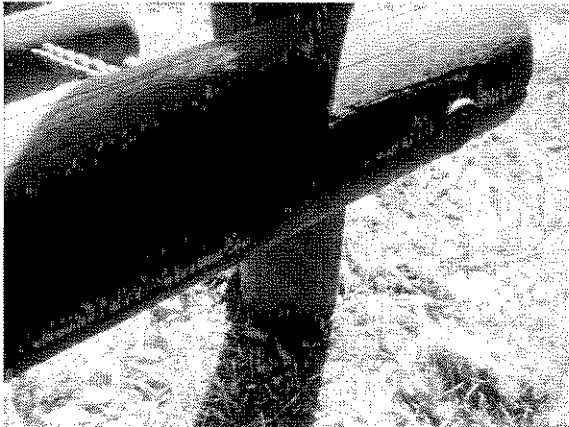
5 - Low Risk (Finding 5)

Finding:	There is/are bolt cap covers missing or damaged on the item	Action:	Replace missing or damaged bolt cap covers
-----------------	---	----------------	--

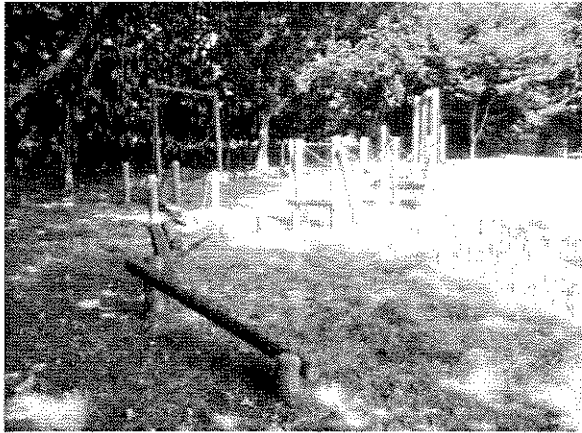
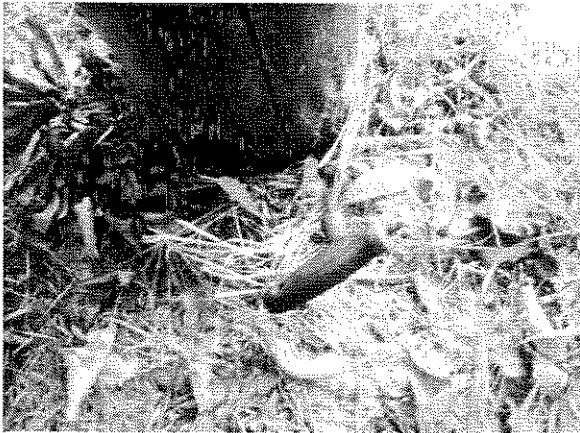
8 - Low Risk (Finding 7)

Finding:	There is some evidence of rot in the timber	Action:	Monitor for any further deterioration and replace as required
-----------------	---	----------------	---

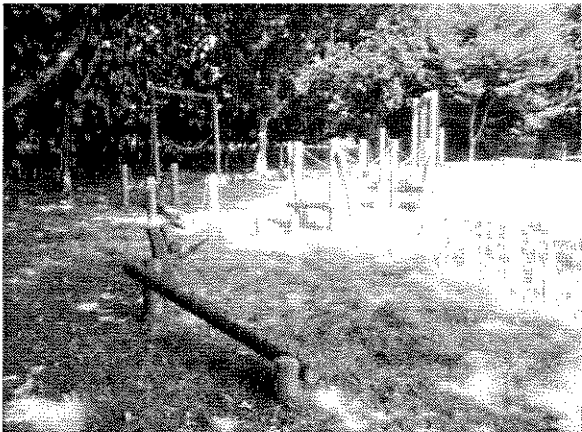
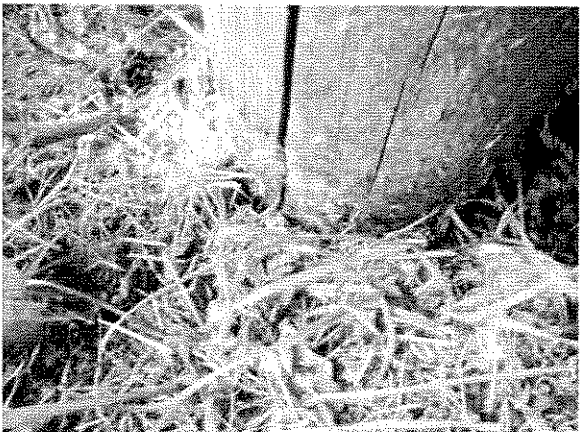
9 - Low Risk (Finding 8)

Finding:	There is some strimmer damage apparent on the posts, this can penetrate the preservative applied to the timber and accelerate the rotting process	Action:	Monitor for any deterioration (rot) and replace as required
-----------------	---	----------------	---

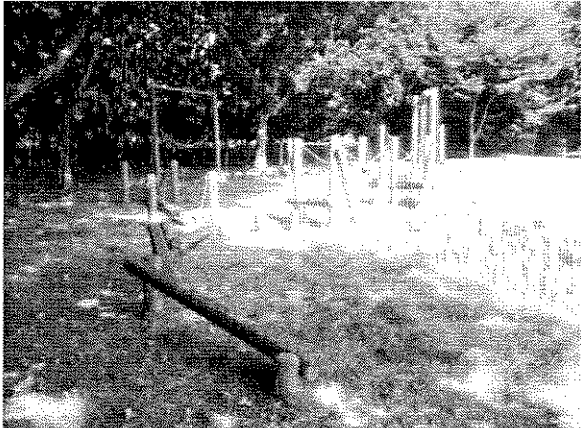
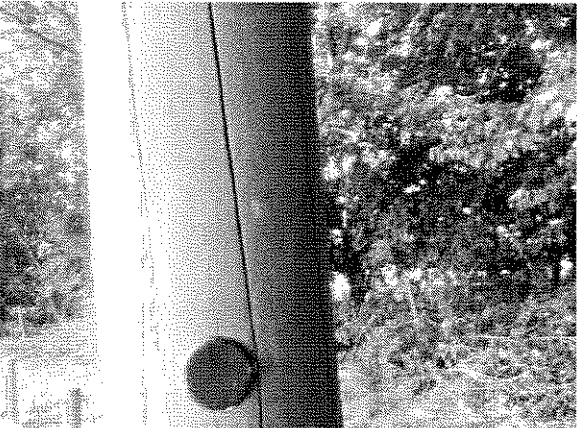
6 - Low Risk (Finding 5)

Finding: The timber has a number of air cracks apparent, the splits will have penetrated the preservative applied to the timber and allow water ingress to the unprotected areas

Action: Monitor for any deterioration (rot) and replace as required

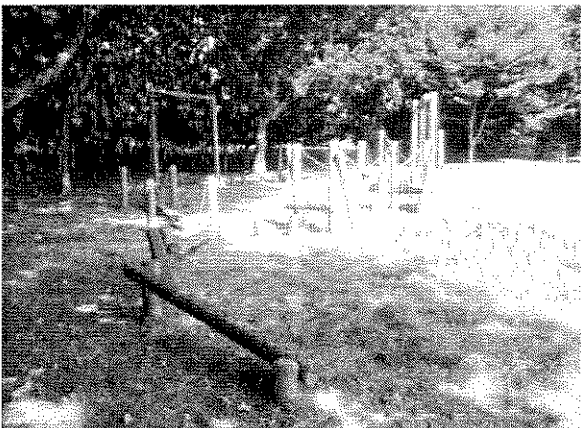
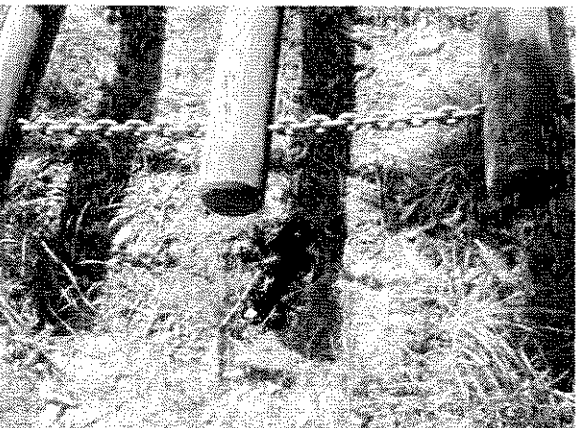
7 - Low Risk (Finding 6)

Finding: The surface has eroded in some areas creating potential trip hazards

Action: Reinststate the surface to remove trip points

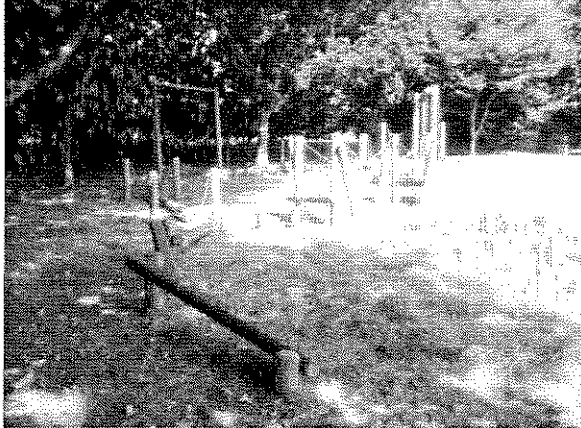
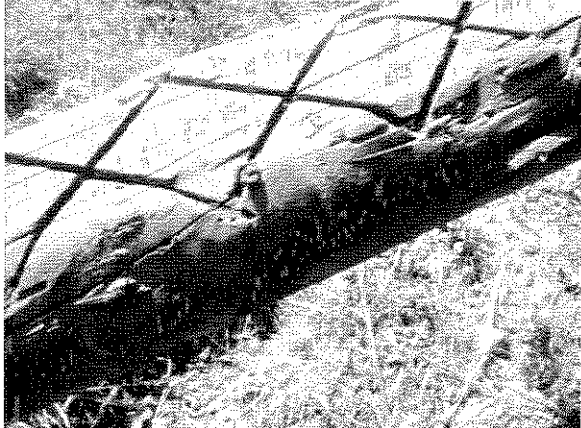
4 - Low Risk (Finding: 1)

Finding:	Parts of the timber are rough or splintered	Action:	Remove all rough or sharp edges
-----------------	---	----------------	---------------------------------

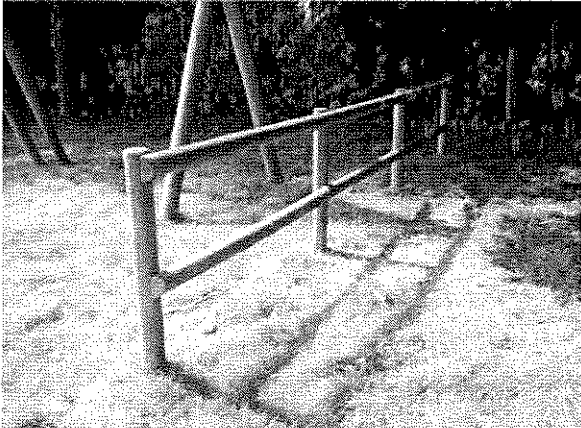
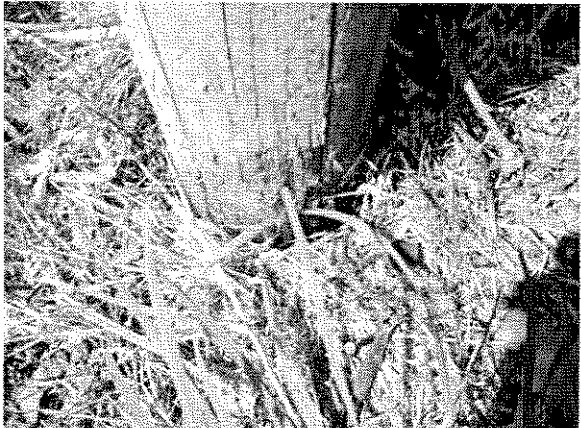
5 - Low Risk (Finding: 1)

Finding:	There is some strimmer damage apparent on the posts, this can penetrate the preservative applied to the timber and accelerate the rotting process	Action:	Monitor for any deterioration (rot) and replace as required
-----------------	---	----------------	---

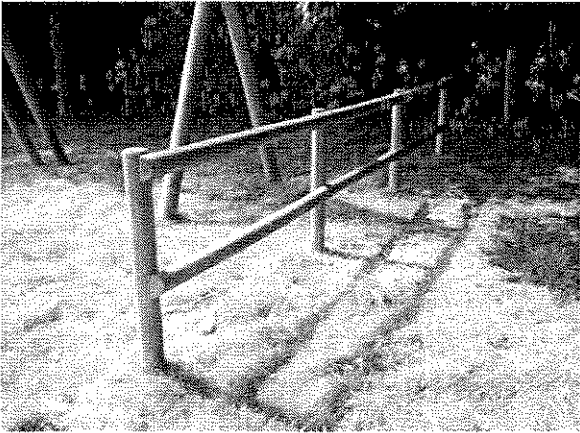
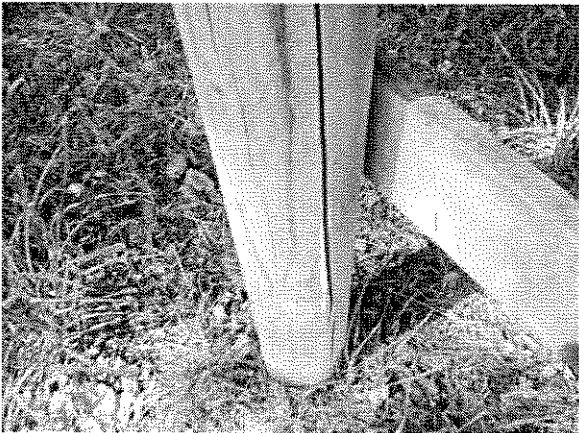
6 - Low Risk (Finding 2)

Finding:	The timber has a number of splits (shakes) although these are not considered to be a problem at present	Action:	Monitor to ensure the splits do not cause any instability and remove any rough or sharp edges
-----------------	---	----------------	---

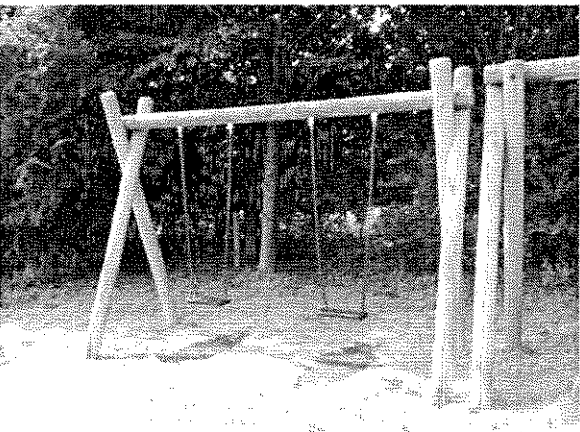
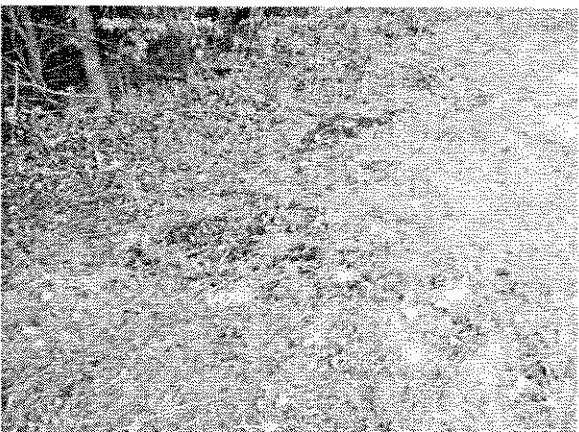
6 - Low Risk (Finding 1)

Finding:	There are weeds/vegetation growth between or around the edges of the surfacing	Action:	Remove weeds/vegetation growth
-----------------	--	----------------	--------------------------------

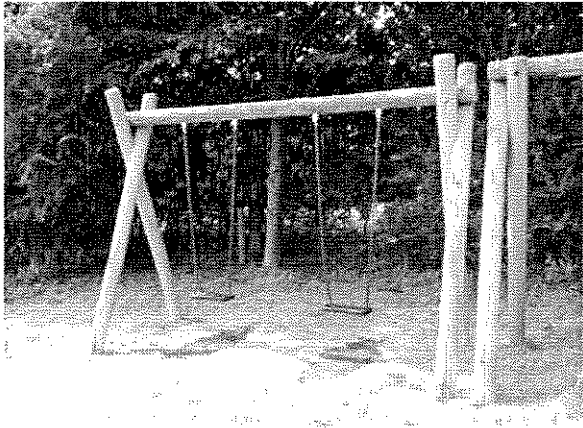
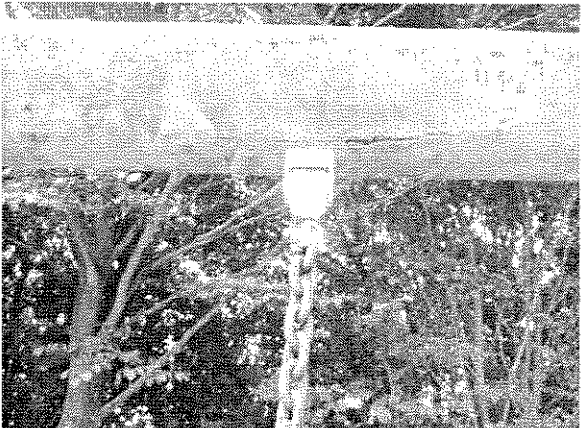
10 - Low Risk (Swinging 2)

Finding: This design of swing joint has been known to fail on the weld connecting the joint to the threaded stud

Action: We would recommend that the joint be dismantled and checked on each Operational Inspection or a Secondary Safety Device be fitted

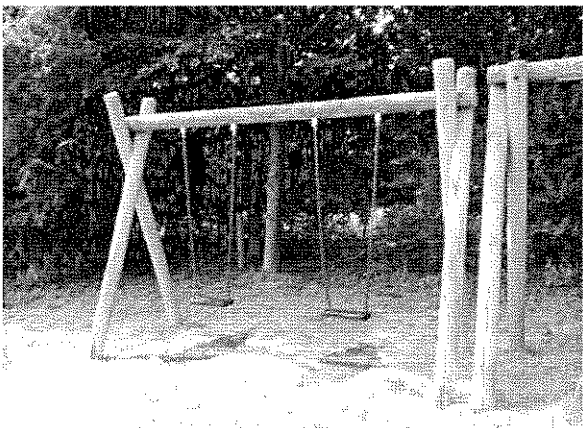
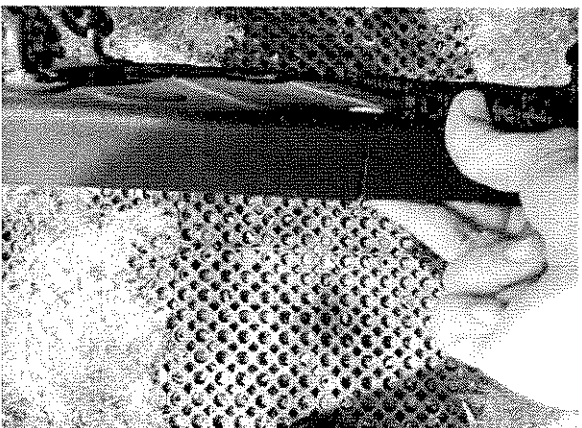
11 - Low Risk (Swinging 2)

Finding: The seat has minor damage or wear

Action: Monitor for any further deterioration and replace as required

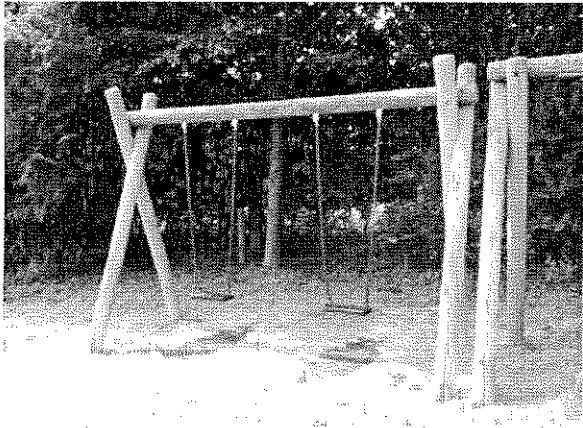
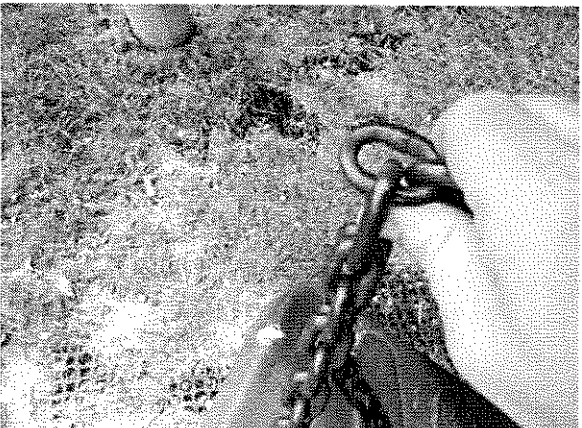
5 - Low Risk (Finding 4)

Finding:	There is some chain wear	Action:	Monitor for any further deterioration and replace when 40% worn
-----------------	--------------------------	----------------	---

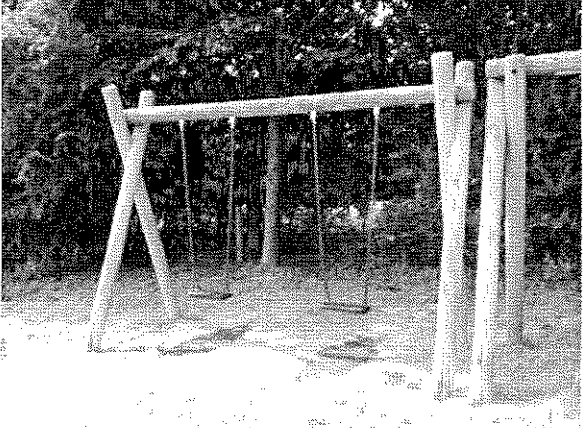
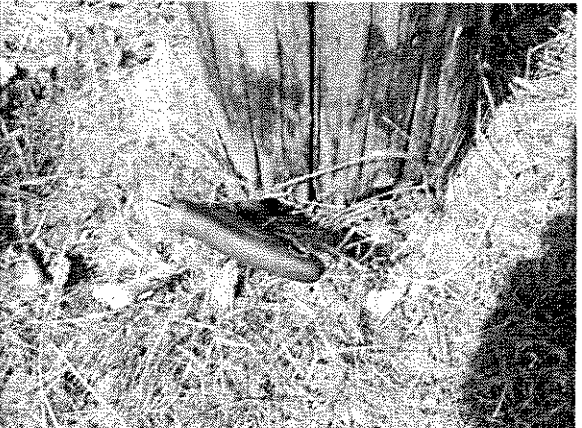
6 - Low Risk (Finding 5)

Finding:	There are areas or parts of the posts on the structure that have rotted	Action:	Replace all affected timbers
-----------------	---	----------------	------------------------------

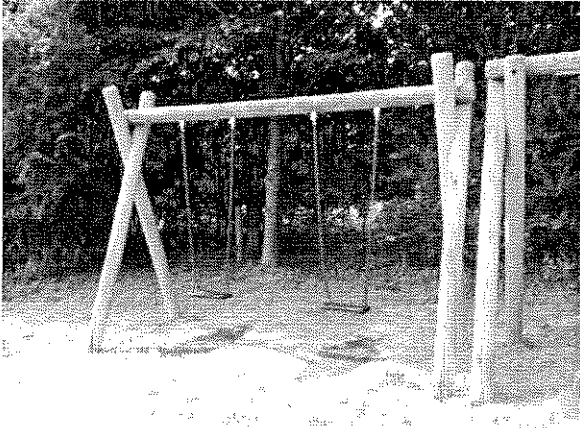
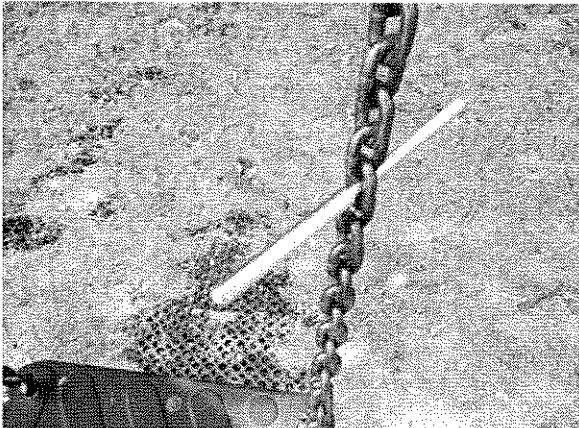
6 - Very Low Risk (Findings 1)

Finding:	The chain openings are in excess of the 8.6mm as recommended by BS EN 1176	Action:	Monitor use and replace with compliant chains during next maintenance cycle.
-----------------	--	----------------	--

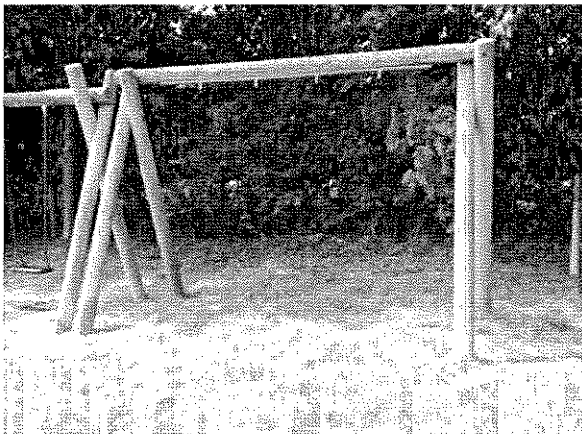
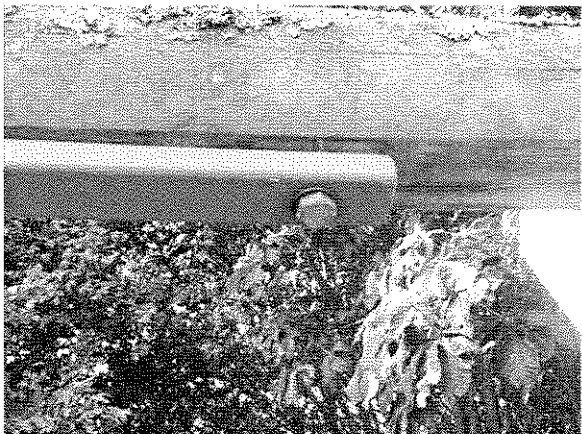
8 - Low Risk (Finding 2)

Finding: A number of fixing(s) have worked loose

Action: Secure all loose fixings

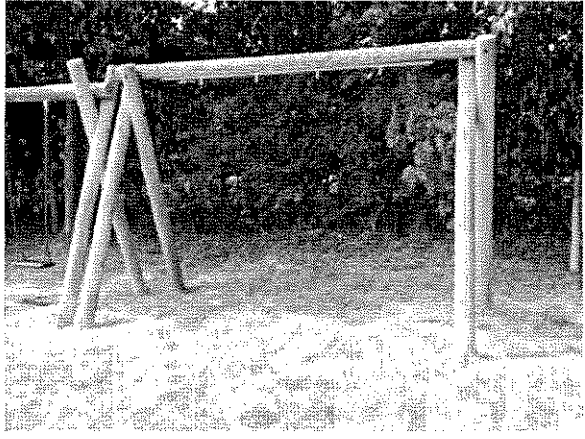
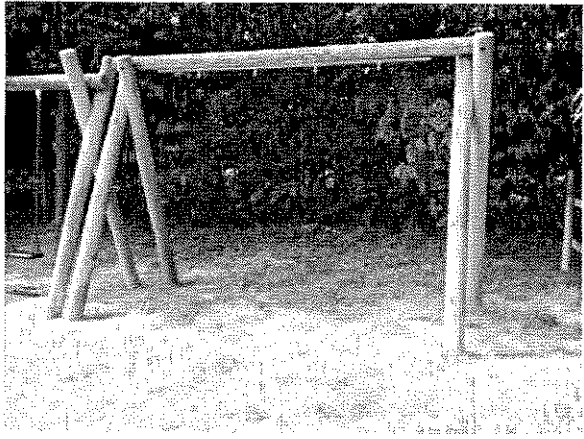
1 - Very Low Risk (Finding 1)

Finding: The seat(s) and suspension were missing at the time of inspection and the inspector was unable to make a full compliance assessment
Action: Replace missing seat(s) and suspension

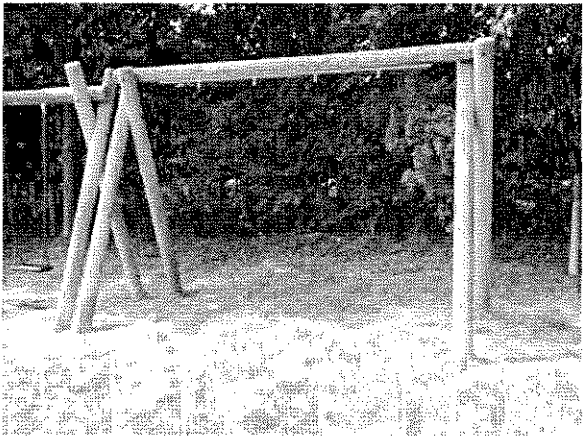
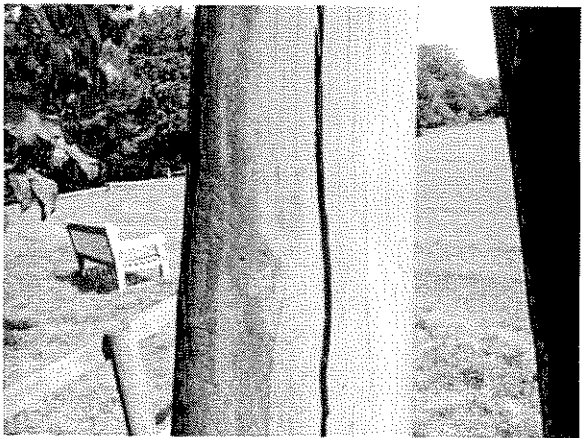
2 - Low Risk (Finding 1)

Finding: The timber has a number of splits (shakes) although these are not considered to be a problem at present
Action: Monitor to ensure the splits do not cause any instability and remove any rough or sharp edges

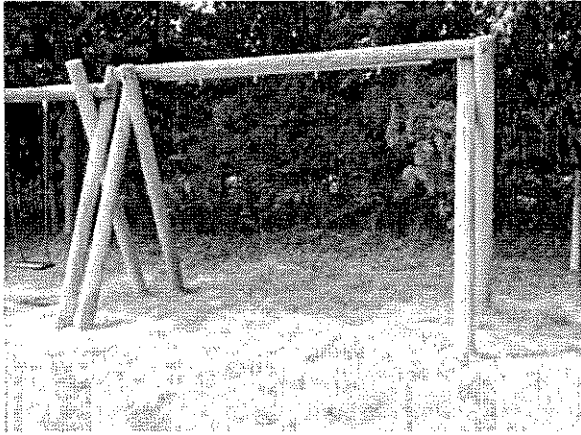
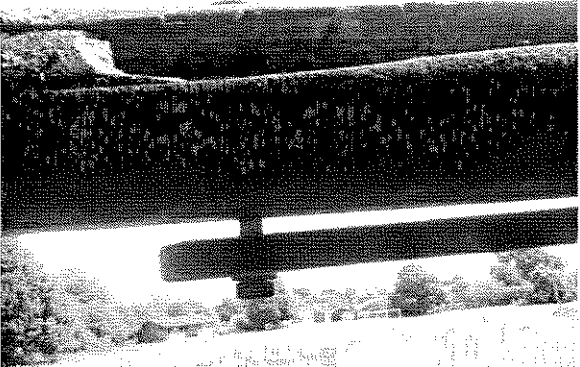
Finding:	The timber crossbeam on this item has severe rot	Action:	Remove and replace all affected timber sections
-----------------	--	----------------	---

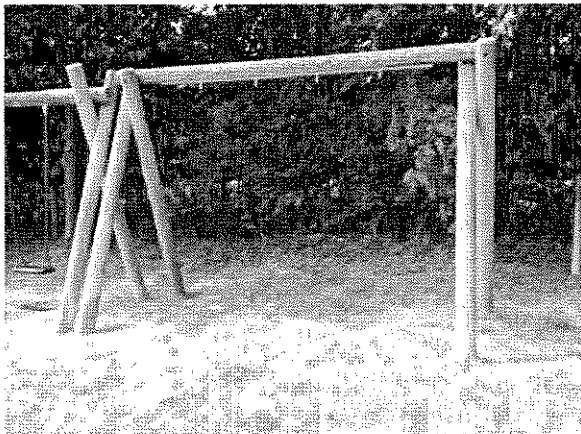
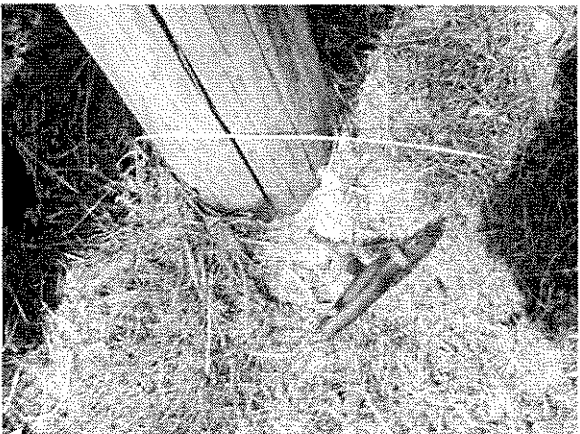
**Low Risk (Finding 6)**

Finding:	There is some evidence of rot in the posts	Action:	Monitor for any further deterioration and replace as required
-----------------	--	----------------	---
